Proposed Development and  
Alterations to N52 Inner Relief  
Road at Crowne Plaza Hotel  
Junction, Dundalk

Stage 1 & 2 Road Safety Audit

<b>Document Ref:</b>	<b>P19-011-RP-001</b>
----------------------	-----------------------

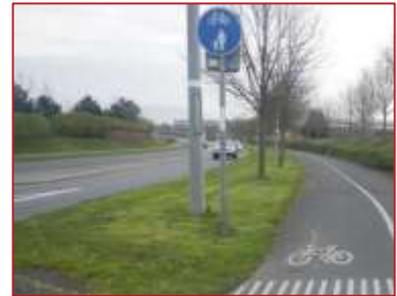
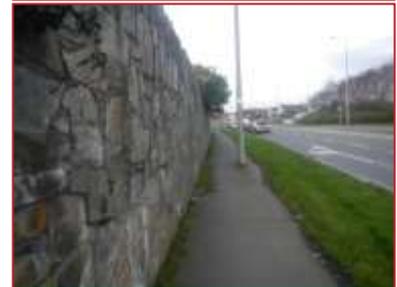
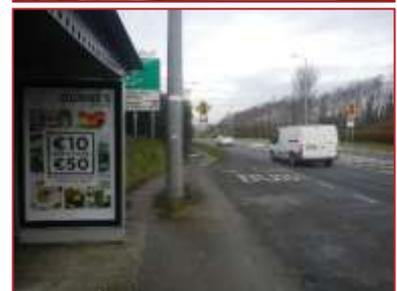
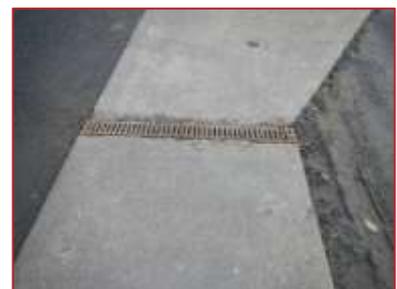
Summary: Existing items of street furniture will require removal or relocation to facilitate the proposed provision of an additional traffic lane on the westbound carriageway.

It is proposed to provide an additional lane on the R215 westbound carriageway which will be achieved by widening into the existing grass verge. During the site visit the Audit Team noted a number of trees, signage and lighting columns within this grass verge which will require removal or relocation. If these lighting columns are located where they will not adequately illuminate the carriageway and footpath/cycletrack there is a risk of dark spots within the carriageway which could lead to restricted inter-visibility between drivers and VRUS resulting in an increased risk of collisions.

It was also noted that the existing bus layby, on the R215 westbound carriageway downstream of the proposed development access junction, has a public lighting column and an associated mini-pillar located centrally within the footpath close to the bus shelter. The location and proximity of these items of roadside furniture present a hazard/obstacle to visually and mobility impaired road users.

Summary: Existing channel drain through the central median at the westbound right turn lane is blocked.

During the site visit, the Audit Team noted that the existing channel drain through the central median was blocked by an accumulation of detritus within the westbound right turn lane at the Crowne Plaza Hotel Junction.

This could lead to ponding on the westbound carriageway should surface water be unable to sufficiently drain from the carriageway. The proposals will result in a greater carriageway surface area draining towards this median/splitter island increasing the likelihood of ponding.

During wet and icy weather ponding at this location could result in a loss of traction between tyres and the road surface resulting in loss of control type incidents and increased injury severity to vehicle occupants.

All items of existing roadside furniture (public lighting columns, signs, bus shelter etc.) should be relocated to a suitable location where they will not constitute a hazard to road users.

Ensure relocated lighting columns are positioned such that they adequately illuminate the footpath/cycletrack and widened carriageway.

Ensure the carriageway can adequately shed surface run-off.

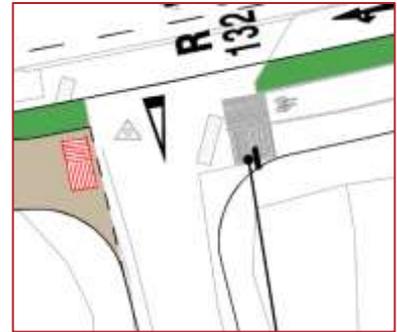
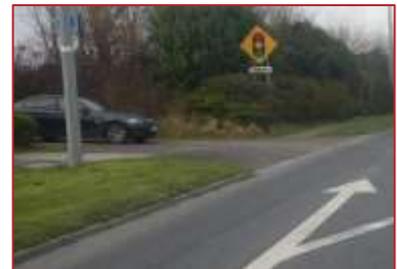
Location: Drawing no. SK-30001 (-)

Summary: The proposed tactile paving arrangement across the gated access to the electrical substation may result in visually impaired pedestrians being insufficiently aware that they are crossing a vehicular access and leaving the VRU facilities.

Ladder and tramline tactile paving is indicated on the western side of the vehicular access to the electrical substation at the commencement of the proposed shared surface while there is existing ladder and tramline tactile paving located on the western side of the access.

Visually impaired pedestrians approaching the access may be insufficiently aware that they are entering a carriageway and may perceive the tactile paving to indicate the end of the segregated facilities. This could lead visually impaired pedestrians inadvertently entering the access where there is a risk of being struck by a vehicle.

As the access to the electrical substation is gated and is likely to be lightly trafficked priority at this location should be given to vulnerable road users by providing a continuous shared surface across the access.

The proposed ladder and tramline tactile paving on the western side of the access would therefore not be required. The existing warning tactile at the access could then be removed, while the existing "Ladder & Tramline" tactile markings should be retained to define the transition from the shared to the segregated surfaces.

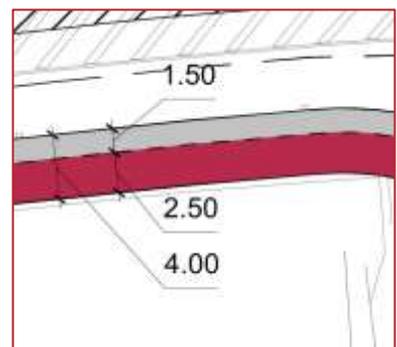
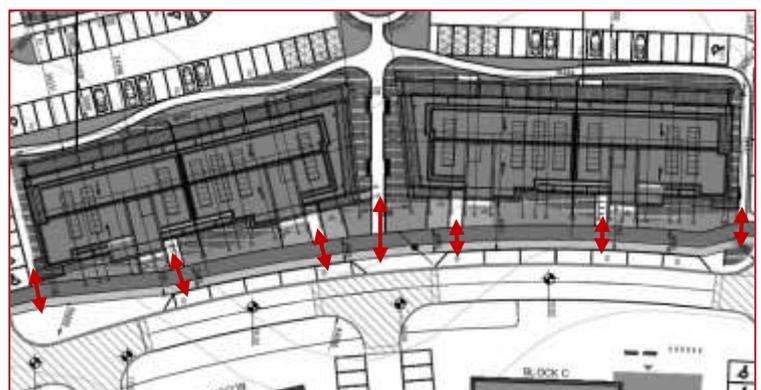
Location: Drawing no. SK-30001 (-)

Summary: The cycletrack has been indicated on the inside of the footpath which is not consistent with the National Cycle Manual preferred arrangement or the existing facilities to the east of the Crowne Plaza Hotel junction.

A segregated footpath and cycletrack has been indicated from the proposed development onto the R215 with the cycletrack indicated on the inside of the footpath which is shown adjacent to the carriageway.

The National Cycle Manual, for all types of segregated cycle facility, shows the cycletrack adjacent to the carriageway. There is an existing segregated facility on the southern side of the R215 to the east of the electrical substation access which has the cycletrack adjacent to the carriageway and the footpath on the inside.

The proposed arrangement extends into the development, where the provision of the footpath adjacent to the carriageway facilitates passenger egress from vehicles parked at the kerb. However, the arrangement shown requires all pedestrians entering/exiting the buildings within the development to cross the cycle track to reach the footpath.

It is likely that cyclists and pedestrians already travelling on the existing westbound facilities east of the Crowne Plaza Hotel junction will then continue travelling within the incorrect path/track downstream of the crossing resulting in the potential for pedestrian-cyclist collisions.

Provide a shared surface instead of separate cycle & pedestrian facilities, which would also remove the need for tactile surfaces at the interfaces with the other shared surfaces along the R215.

Alternatively, amend the segregated pedestrian and cyclist facilities so that the footpath is on the inside and the cycletrack is adjacent the carriageway. The footpath level should be above the level of the cycletrack.

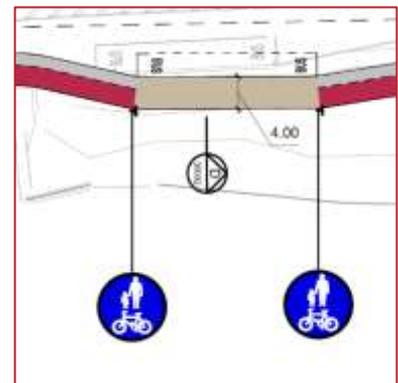
*Location:* Drawing no. SK-30001 (-)

*Summary:* Ladder and tramline tactile paving has not been indicated either side of the proposed shared surface at the westbound bus layby or at the transition to the shared surface on the westbound approach to the R132 junction.

The segregated footpath and cycletrack transitions to a shared surface at the bus layby on the westbound carriageway of the R215 and on the approach to the R132 junction.

Ladder and tramline tactile paving has not been indicated at the start and end of this section of shared surface. This could lead to visually impaired pedestrians approaching the shared surface in the footpath being insufficiently aware that they are entering a shared area where cyclists may also be present which could result in an increased risk of pedestrian-cyclist collisions.

Provide ladder and tramline tactile paving at the interfaces between shared and segregated surfaces.

Alternatively, as recommended in Problem 3.1.4, a shared surface could be provided throughout the Scheme in lieu of the proposed segregated pedestrian & cyclist facilities.

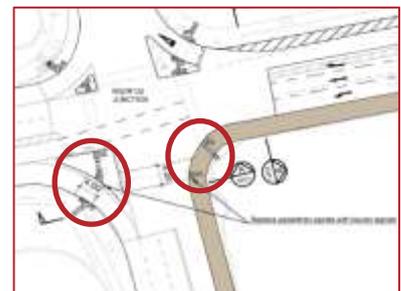
*Location:* Drawing no. SK-30001 (-)

*Summary:* Existing tactile paving provision, as indicated on the drawing, may not be appropriate for the proposed toucan crossings.

It is proposed to replace the existing, although possibly unused, pedestrian crossing of the R132, south of the R215 junction, and the associated segregated left turn slip with toucan crossings to facilitate both pedestrians and cyclists.

The existing tactile paving arrangement is indicated as being retained at these crossings, including one provision where chamber covers encroach into the tactile paving layout.

This existing tactile paving arrangement may not be appropriate for the proposed Toucan crossings, which are 4m wide, as the existing tactile paving will not extend across the full width of the proposed crossing. This could lead to visually impaired pedestrians inadvertently entering the carriageway where the tactile paving does not extend over the full width of the dropped kerb with a resulting increased risk of being struck by a vehicle.

The existing tactile paving arrangements should be replaced or amended with new tactile paving suitable for the proposed toucan crossing.

It may also be necessary to change the existing pedestrian crossings of the R215 to the west of the junction to toucan crossings, or to provide 'box turn' arrangements, to facilitate cyclists wishing to travel northbound from the R215 westbound approach.

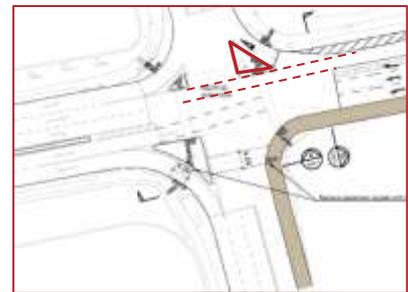
*Location: Drawing no. SK-30001 (-)*

*Summary: Risk of eastbound drivers entering the incorrect lane downstream of the junction as lane guidance markings have not been provided for this movement.*

The inclusion of an additional third lane on the westbound carriageway of the R215 results in the through traffic lanes being offset from the downstream lane on the other side of the junction. Lane guidance markings have been indicated for westbound drivers travelling straight-ahead at the R132/R215 junction, however no guidance markings have been indicated for eastbound straight-ahead traffic. This could lead to eastbound drivers potentially entering the opposing right turn lane where there is a risk of head-on collisions with vehicles waiting in this lane.

In addition, large eastbound vehicles may strike the existing splitter island in the north-eastern quadrant of the junction as they enter the downstream eastbound lane resulting in material damage collisions.

Provide lane guidance markings at the R132/R215 junction for the eastbound through movement. The north-eastern splitter island may also require amendment to ensure all vehicles can safely undertake the through movement within the carriageway extents.

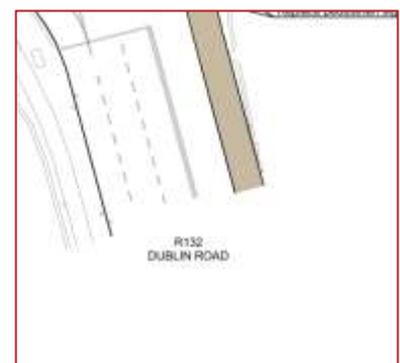
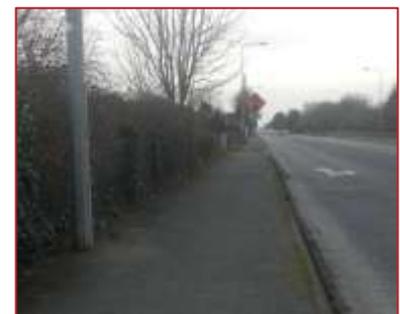
*Location: Drawing no. SK-30001 (-)*

*Summary: Proposed shared surface on the R132 does not tie-in with similar facilities.*

A shared surface of width 3.0m is proposed on the southern side of the R215 carriageway, which extends onto the R132, terminating south of the R132/R215 junction. This proposed facility does not tie-in with an existing facility at this location and the existing footpath at this location is not wide enough to accommodate both pedestrians and cyclists. Should vulnerable road users be directed onto this existing footpath there is a risk of collisions between pedestrians and cyclists.

The arrangement at the tie-in of the proposed shared surface and the existing footpath on the R132 should be amended so that southbound cyclists are safely transitioned onto the southbound R132 carriageway to continue their journey.

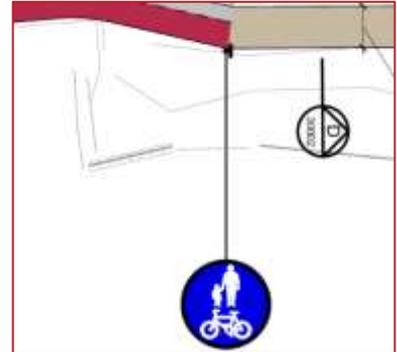
1. Advance stacking locations (ASLs) have been indicated on the approaches to the Crowne Plaza Hotel junction. Section 4.4.1 (point no. 6) of the National Cycle Manual states that “ASLs must always be “fed” by a cycle lane to ensure that cyclists can pass stationary traffic and get to them.” No on-road cycle facilities are proposed on the approaches to the ASLs, and it may be preferable to omit them from the design.
2. The shared surface sign indicated at the western side of the shared surface at the bus layby on the westbound carriageway of the R215 is indicated as facing in the incorrect direction. This should be amended to face towards pedestrians and cyclists approaching from the west.

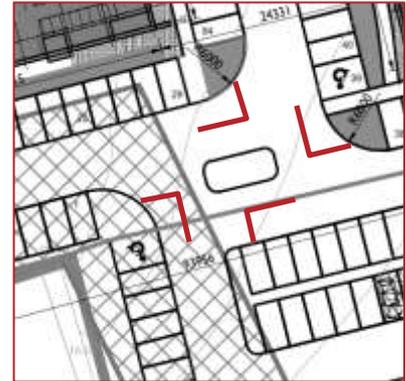
*Location:* Drawing no. 1611-PA-003

*Summary:* Priority at the roundabout island at the entrance to the cluster of apartment blocks within the proposed development is unclear.

A rectangular island has been indicated within one of the development car parks. The Audit Team have assumed that this is intended to function similar to a roundabout. It is however unclear, due to the lack of signs or roadmarkings at this location, who has priority at this junction or what movements are permitted. Should priority at this junction be unclear this could lead to drivers on opposing arms entering the junction simultaneously leading to an increased risk of collisions and injuries to vehicle occupants.

Provide clear guidance to drivers, through the provision of signs and roadmarkings, as to which arms of the junction have priority and what movements are permitted at this location.

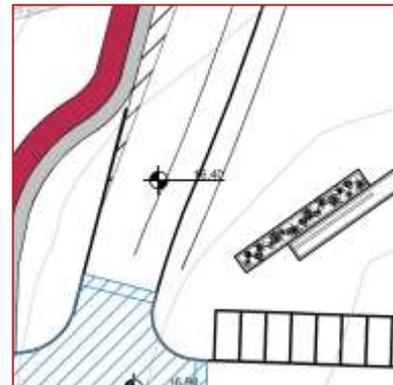
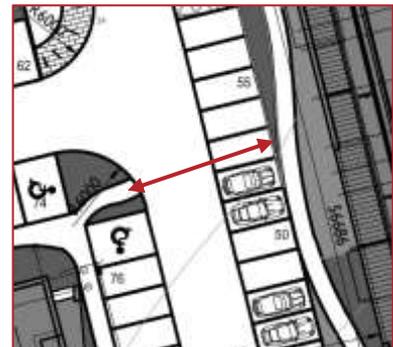
*Location:* Drawing no. 1611-PA-003

*Summary:* The pedestrian routes through the proposed development are unclear, including where crossings are proposed, the arrangement of the VRU facilities (shared or segregated) and the lack of tactile paving at proposed crossing points.

The footpath on the western side of the access road to the proposed development appears to terminate south of the Crowne Plaza Hotel junction without connecting to other pedestrian routes.

Apart from the primary footpath/cycletrack through the spine of the development, the footpath arrangements within the development, outside the public open space and cluster of apartment blocks, is unclear.

Crossing locations are not clearly indicated and where crossings appear to have been provided these do not line up with an opposing footpath, while some terminate at car parking spaces.

A failure to provide suitable access points to the footpaths could lead to mobility impaired pedestrians, who cannot mount a full-height kerb, becoming stranded within the carriageway or having to travel within the carriageway to the nearest dropped kerb location resulting in an increased risk of being struck by a vehicle.

Tactile paving is also not indicated within the development which increases the difficulty in determining where proposed crossing points are located. If tactile paving is not provided at crossing points this could lead to visually impaired pedestrians inadvertently entering the carriageway where they are at risk of being struck by a vehicle.

Ensure the pedestrian routes within the proposed development are continuous, clearly defined and include dropped kerbs and tactile paving at all crossing points.

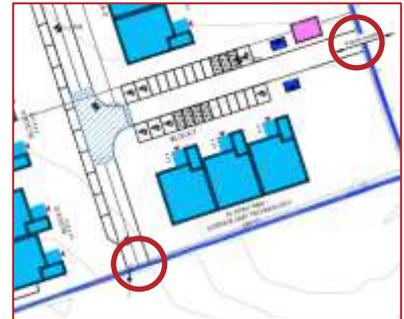
Location: Drawing no. 1611-PA-003

Summary: *Turning heads have not been indicated at the end of cul de sacs within the proposed development.*

Cul de sacs have been indicated throughout the proposed developments. Turning heads have not been indicated at the end of cul de sacs in all instances.

A failure to provide a turning head at these locations could result in large vehicles being unable to undertake a u-turn manoeuvre within the carriageway resulting in them undertaking unsafe reversing manoeuvres where there is a risk of collisions with other road users.

Turning heads should be provided at the end of cul de sacs.

The ends of some cul de sacs have been indicated as being designated for future access to the proposed development. Nevertheless, in the interim, turning heads should also be provided at these locations.

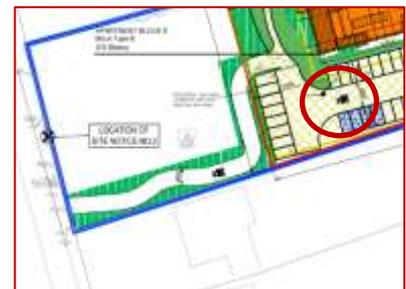
1. It is unclear if the link from the western boundary of the proposed development to the R132 is a shared area for all vulnerable road users or just cyclists. The shared area for motorised and non-motorised road users within the development, if this is what is intended, should be highlighted through the provision of alternative surface materials rather than a cycle symbol to avoid confusion. Also, if the link to the R132 is not intended for motorised vehicles measures should be provided at each end to deter drivers from entering the facility.

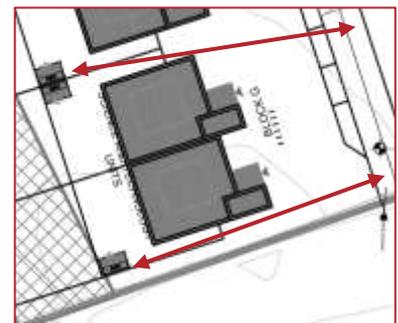
2. Bin stores have been indicated adjacent the buildings within the proposed development. Some of the bin-stores are indicated away from the carriageway (e.g. for Science & Technology Units Block G & H or to the rear of parking spaces (Block B)).

Bins could be left in inappropriate locations for collection which could lead to refuse trucks stopping at unsafe locations in order to collect them. Bins left within footpaths or cycle tracks could present a hazard to these road users.

Designated locations should be identified throughout the development, close to the carriageway, where bins can be easily transported to for safe collection.
