Proposed Development and  
Alterations to N52 Inner Relief  
Road at Crowne Plaza Hotel  
Junction, Dundalk

Stage 1 & 2 Road Safety Audit

<b>Document Ref:</b>	<b>P19-011-RP-001</b>
----------------------	-----------------------

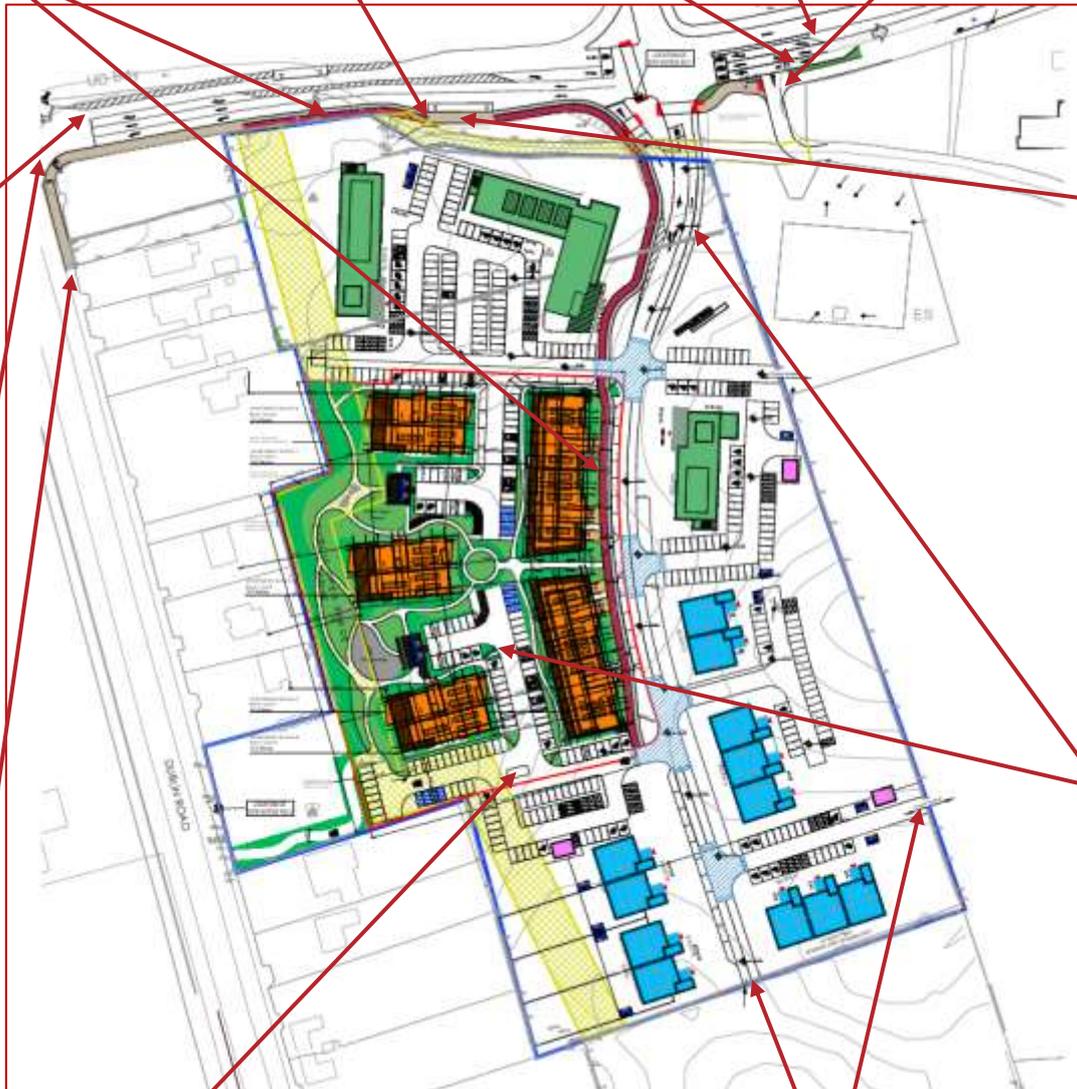
**Problem 3.2.1:** Priority at the roundabout island at the entrance to the cluster of apartment blocks within the proposed development is unclear.

**Problem 3.2.3:** Turning heads have not been indicated at the end of cul de sacs within the proposed development.
